# White Roads EU PROJECT

Final Report (D 0.3)

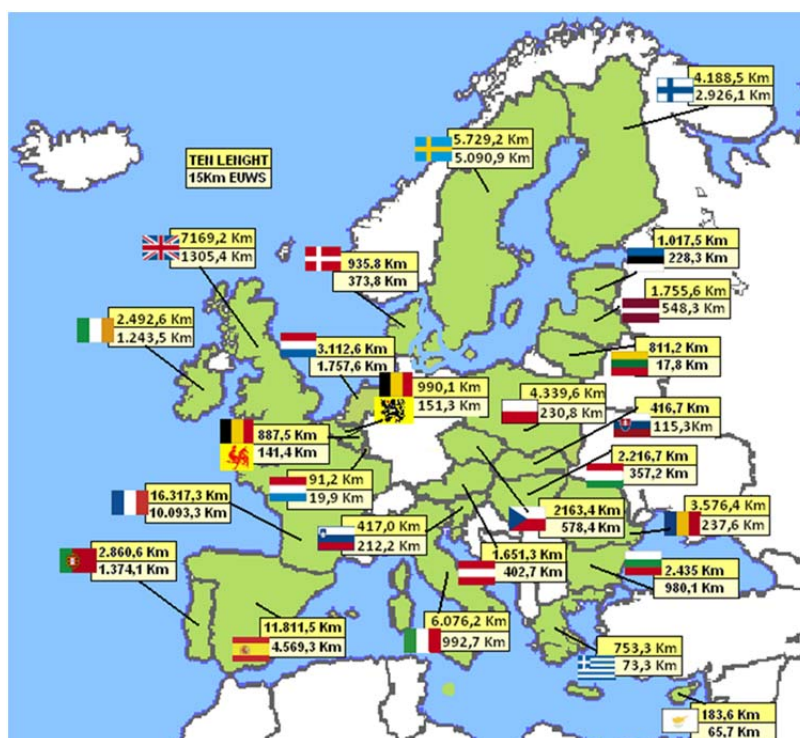
Map 2. Number of white Kms per Member State

Below another map indicating the number of white Kms per member state in comparison to the number of TEN-T Kms analysed:

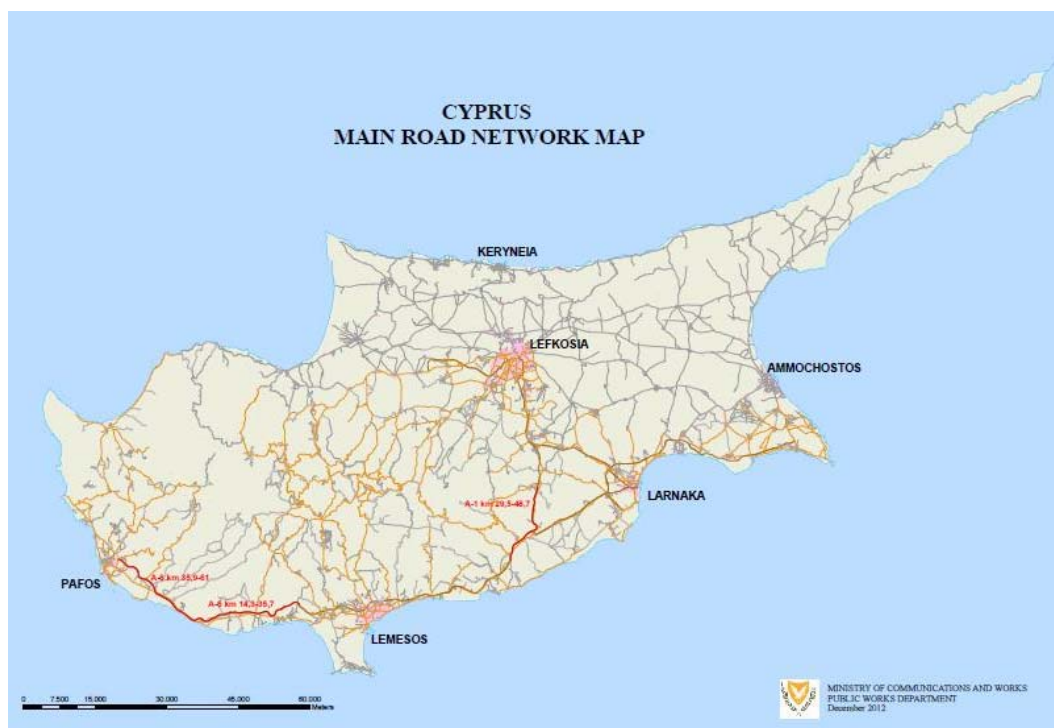
Map 7. Location of EUWS in Cyprus

TEN road networks in Cyprus have a length of 183,6 km divided into 5 sections of national roads. After the analysis of the accident database, 3 white spots have been identified in 2 roads: A1, A6.

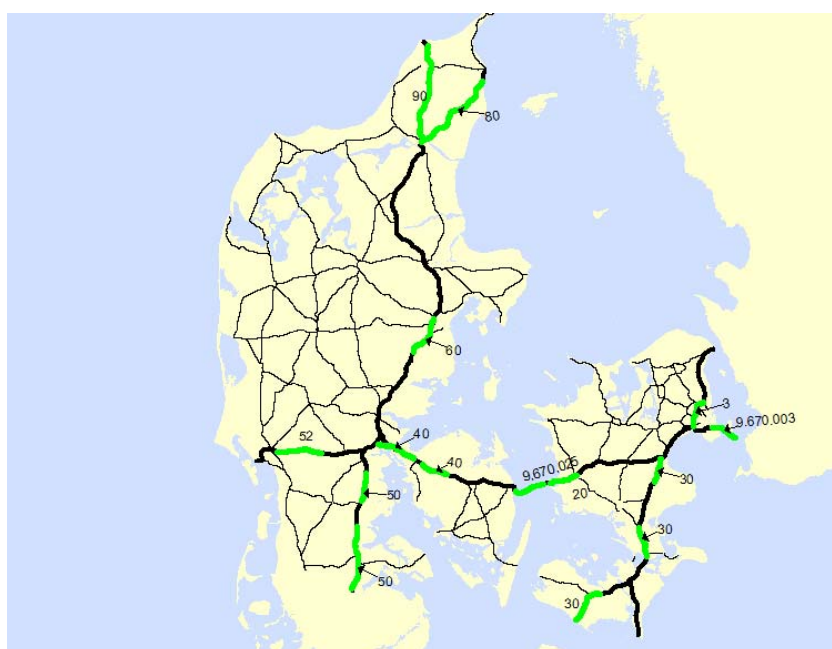
Map 8. Location of EUWS in Denmark

TEN-T road network in Denmark has a length of 2.709,2 km divided into 15 sections of national roads. After the analysis of the accident database, 26 white spots have been identified in 10 roads: 3, 20, 30, 40, 50, 52, 60, 80, 90, 9670003, 9670025.

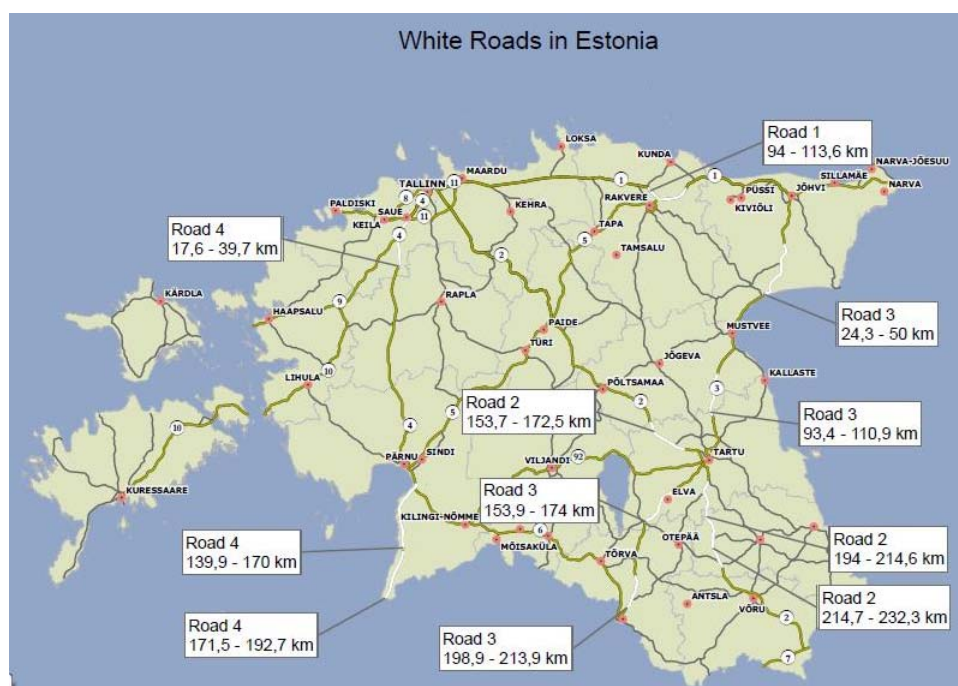
Map 9. Location of EUWS in Estonia

TEN-T road network in Estonia has a length of 1.017,5 km divided into 7 sections of national Roads. After the analysis of the accident database, 11 white spots have been identified in 4 roads: 1, 2, 3, 4. Detailed information about EUWS in Estonia can be found in D4.6 (Report on WS in Baltic countries).

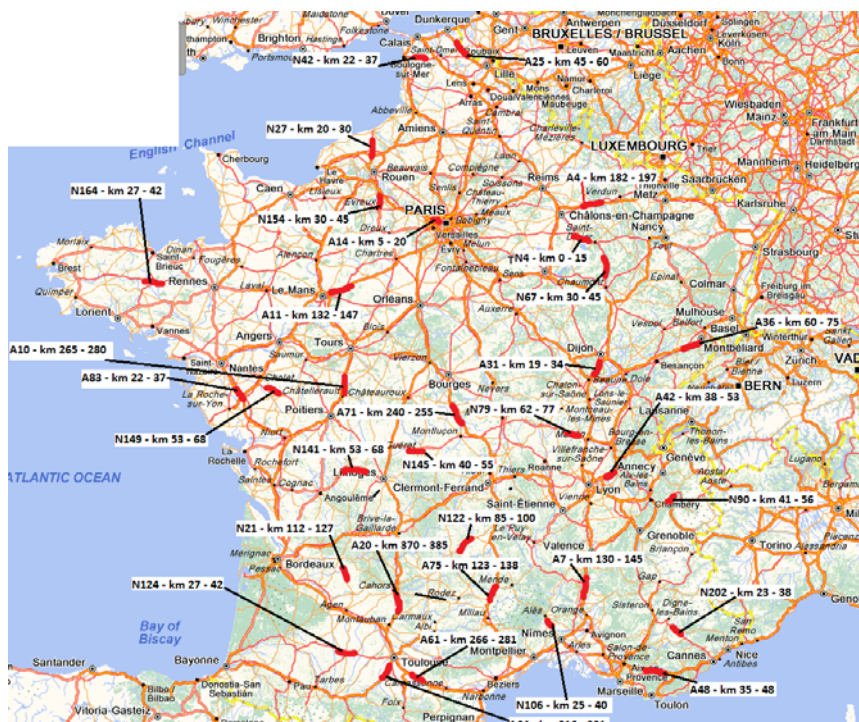
Map 10. Location of EUWS in France

The map below of EUWS in France reflects only those sections which has been analysed during the on-site inspection of D4.2 (further details can be found in this Deliverable).

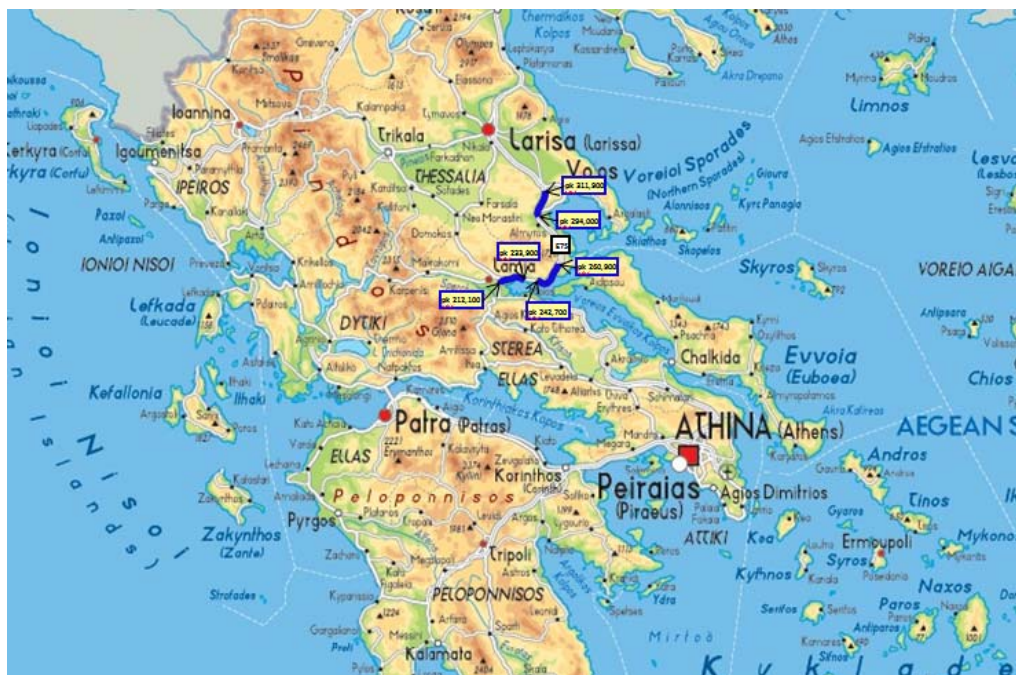
Map 11. Location of EUWS in Greece

TEN-T road networks in Greece have a length of 753,7 km divided into 4 sections of national roads. After the analysis of the accident database, 4 white spots have been identified in 1 road: E-75 Athens-Evzoni.

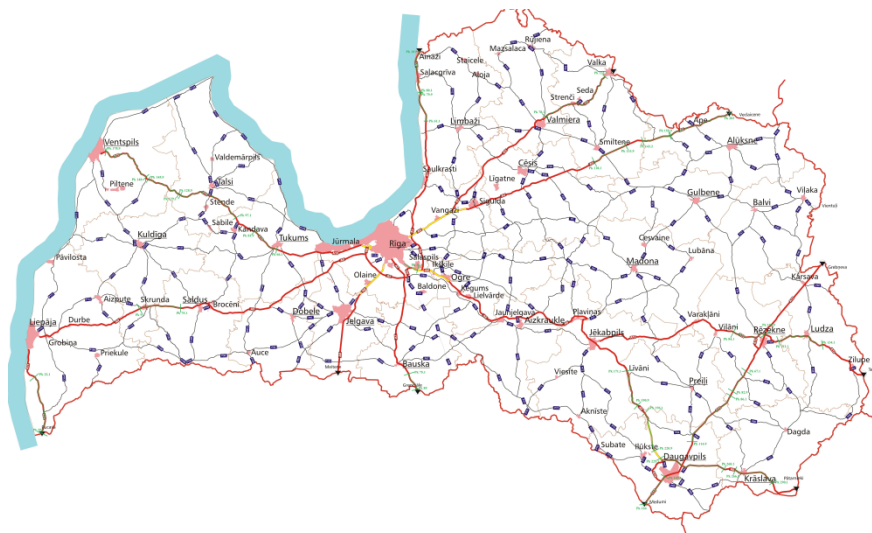
Map 19. Location of EUWS in Latvia

TEN-T road network in Latvia has a length of 1.755,6 km divided into 15 sections of national roads. After the analysis of the accident database, 23 white spots have been identified in 10 roads: A1, A2, A3, A6, A7, A9, A10, A11, A12, A13. Further information about the onsite inspections of EUWS in Latvia can be found in Deliverable 4.6 (Report on WS in Baltic countries).

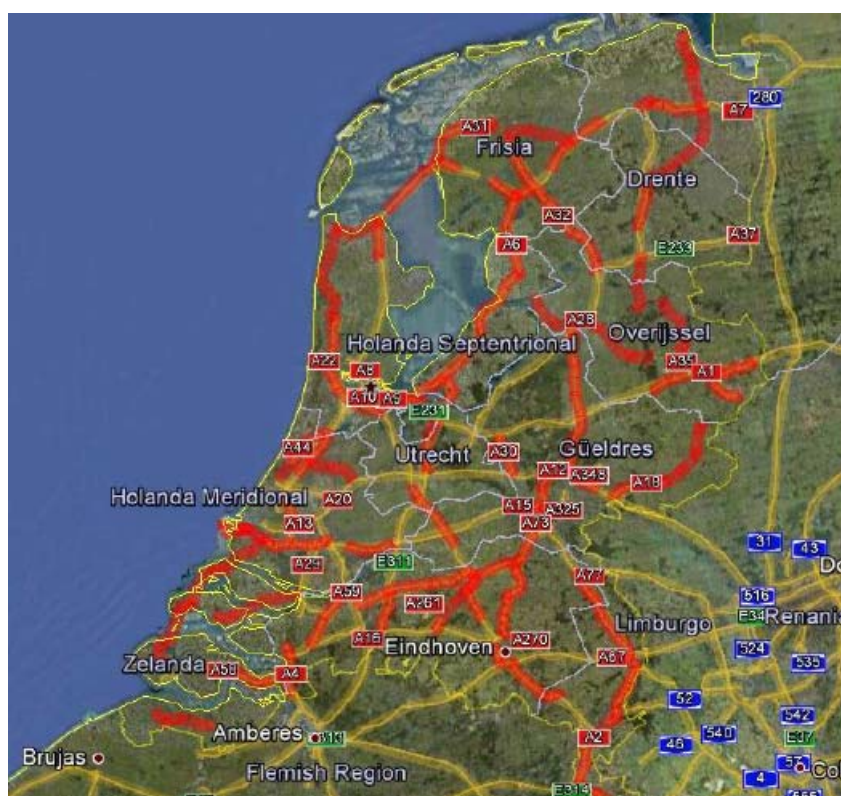
Map 28. Location of EUWS in The Netherlands

TEN-T road network in The Netherlands has a length of 3.112,6 km divided into 57 sections of national roads. After the analysis of the accident database, 59 white spots have been identified in 32 roads: 1, 2, 4, 6, 7, 9, 11, 12, 13, 15, 17, 27, 28, 30, 31, 32, 33, 35, 36, 44, 48, 50, 57, 58, 59, 61, 65, 73, 76, 79, 99, 835.

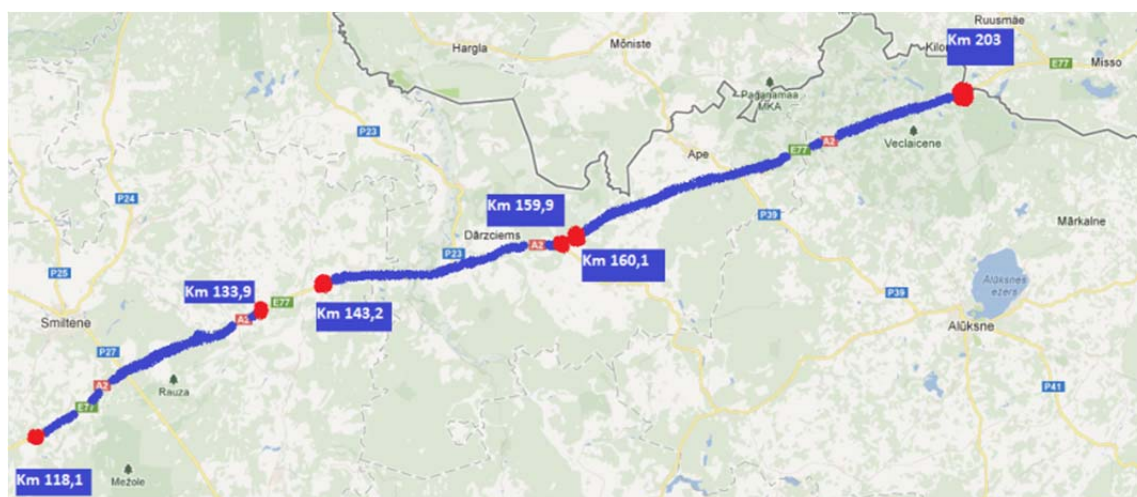
Map 37. EUWS on road A2/E77

- A2 / E77: from Km 118,1 to Km 133,9
- A2 / E77: from Km 143,2 to Km 159,9
- A2 / E77: from Km 160,1 to Km 201

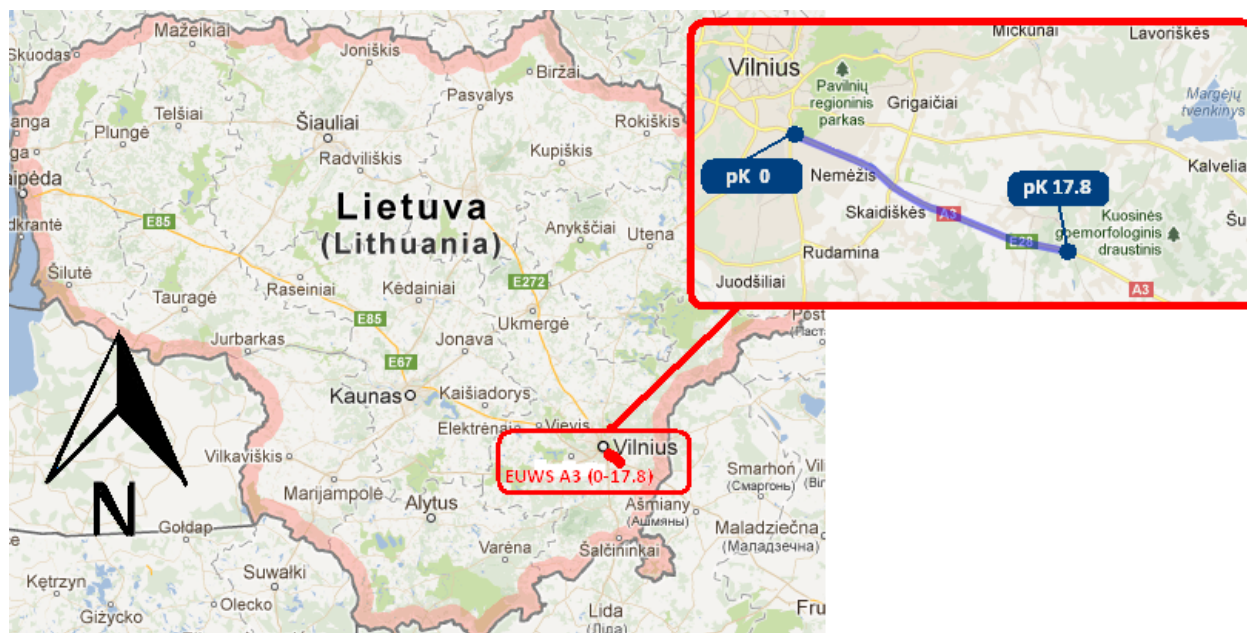
Map 39. EUWS on motorway A3

- ✓ **TEN-T Road A3:**
  - From Km 0 to Km 17.8.

The field work conducted along EUWS in Lithuania concluded that this particular road section present in general a good standard of design, appropriate road equipment, as well as a good level of maintenance, although the presence of pedestrian crossing, pedestrian or change of level at the same level is a risk for road safety.

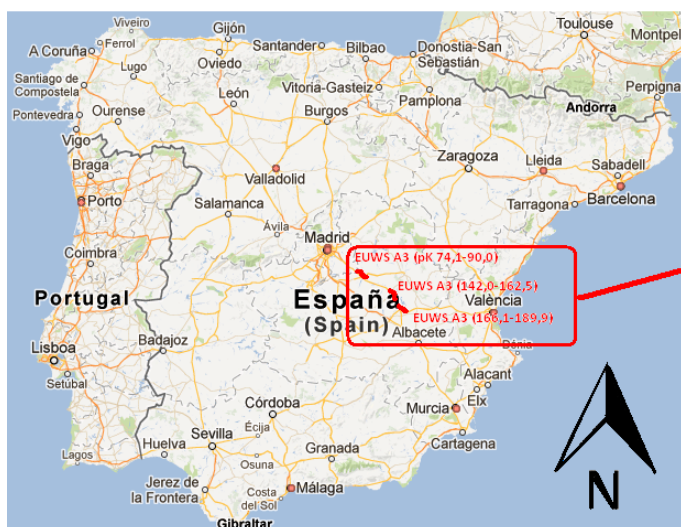
Map 41. EUWS on motorway A3

- From Km 74.1 to Km 90.0.
- From Km 142.0 to Km 162.5.
- From Km 166.11 to Km 189.9.

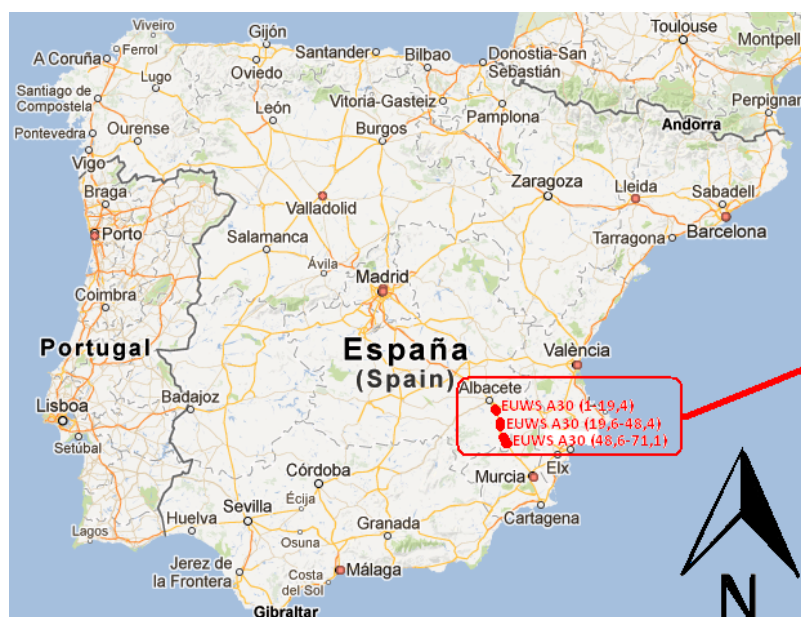
Map 42. EUWS on motorway A30

- From Km 1.0 to Km 19.4.
- From Km 19.6 to Km 48.4.
- From Km 48.6 to Km 71.1.

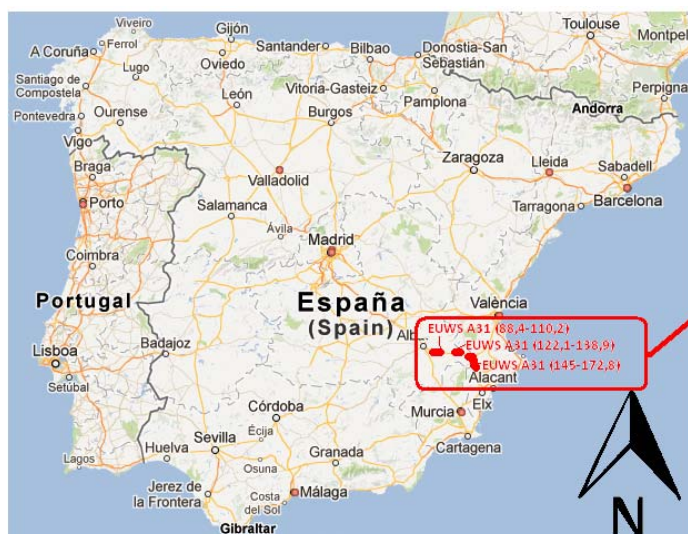
Map 43. EUWS on motorway A31

- From Km 88.4 to Km 110.2.
- From Km 122.1 to Km 138.9.
- From Km 145.0 to Km 172.8

The field work conducted along EUWS in Spain concluded that these particular road sections present a good standard of design, appropriate road equipment, as well as a general good level of maintenance, although the presence of potholes and cracking is usual.
